# Public Toilets Chintamani City

## Assessment Report

(Using Sanitation Mapping Tool)

Under Integrated Water Management (IWM) Project

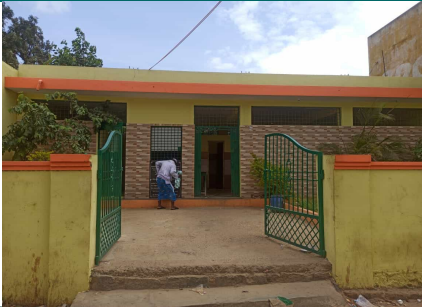
Unique ID - 7J5WC323+9J

<b>Address</b>	BSNL Office Double Rd Chintamani	<b>Location</b>	Other:, Bengaluru Circle
<b>Facility is constructed by</b>	Urban Local Body (Municipality or Municipal Corporation)	<b>O&amp;M agency</b>	Sri Sai Foundation
<b>Most type of users</b>	Nearby shop owners/office employees/visitors	<b>Estimated number of users per day</b>	300
<b>Open 24x7</b>	No	<b>Opening time</b>	06:00
<b>Plan type of Facility</b>	Besides	<b>Closing time</b>	20:00

Cleanliness category of the Facility	Mandatory Service Indicators Score	Essential Service Indicators Score	Desirable service Indicators Score	Aspirational service Indicators Score
Unusable	55%	30%	40%	45%

Water availability	Adequacy of facility	Overall Condition of the Building	Overall cleanliness of facility	Overall cleanliness of basins	Overall Lighting Facility
24x7	Adequate	Fair	Fair	Fair	Natural ventilation

Overall cleanliness of the facility	Fair	Supply of consumables cleaning equipment and inventory (Phenyl, Acid, Broom, Bucket, Mug)	Yes
Method of cleaning of toilet facility	Manually	Use of protective gears	No
No. of times facility cleaned in a day	1	Availability of day light	Natural ventilation
Supervisor/ caretaker on duty	Yes	Obstructions while accessing facility	Gathering of males
Responsible for cleaning facility	Hired by O & m agency	Plants / shrubs in the vicinity of toilet block are well maintained	Yes
Stain / graffiti free walls and floors	Yes

Infrastructure required			
Toilet seat replacement (male and female)	0	Mugs/ bucket	0
Taps	0	Ventilators/ Exhaust fans	0
Flush for toilet facility	19	Hooks for hanging clothes	13
Door with proper latch	0	Separate lights in cubicles	13
Contact information display	1	Directional signage	1
Urinal Elements			
Total urinal pot (install/replace)	0	Discharge drain pipes in Urinal	0
Washbasin Elements			
Total wash basin (install/replace)	0	Drain pipes for wash basins	0
Infrastructure required specific to differently abled section			
Ramp with hand rails for wheelchair	Yes	Barrier free access inside the facility	0
Disabled friendly cubicle size	0	Grab bar	0
Disabled friendly toilet seat	0	Wash basin at disabled friendly height	0
Infrastructure required specific to child friendly section			
Child friendly toilet seat	0	Urinal pot at child friendly height	0
Wash basin at child friendly height	0		
Other required amenities (as per ODF+ guidelines)

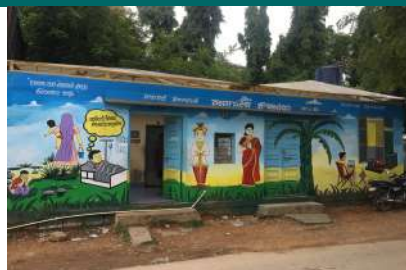
Unique ID - 7J5W93W2+RQ

General Information			
<b>Address</b>	Public Toilet Chintamani Chikballapur	<b>Location</b>	Other., IB Circle ( Opp, CMC )
<b>Facility is constructed by</b>	Private agency/Trust/NGO	<b>O&amp;M agency</b>	Surya International Social service organization, Bangalore
<b>Most type of users</b>	Nearby shop owners/office employees/visitors	<b>Estimated number of users per day</b>	700
<b>Open 24x7</b>	No	<b>Opening time</b>	06:00
<b>Plan type of Facility</b>	Besides	<b>Closing time</b>	19:00

Water availability	Adequacy of facility	Overall Condition of the Building	Overall cleanliness of facility	Overall cleanliness of basins	Overall Lighting Facility
Few hours a day	Inadequate	Bad	Bad	No Washbasins	Natural ventilation

Overall cleanliness of the facility	Bad	Supply of consumables cleaning equipment and inventory (Phenyl, Acid, Broom, Bucket, Mug)	No
Method of cleaning of toilet facility	Manually	Use of protective gears	No
No. of times facility cleaned in a day	1	Availability of day light	Natural ventilation
Supervisor/ caretaker on duty	Yes	Obstructions while accessing facility	Poor condition of path, Parking, Encroachment by vendors/hawkers, Gathering of males
Responsible for cleaning facility	Hired by O & m agency	Plants / shrubs in the vicinity of toilet block are well maintained	No
Stain / graffiti free walls and floors	No

Infrastructure required			
Toilet seat replacement (male and female)	2	Mugs/ bucket	2
Taps	4	Ventilators/ Exhaust fans	0
Flush for toilet facility	10	Hooks for hanging clothes	6
Door with proper latch	0	Separate lights in cubicles	6
Contact information display	0	Directional signage	1
Urinal Elements			
Total urinal pot (install/replace)	0	Discharge drain pipes in Urinal	4
Washbasin Elements			
Total wash basin (install/replace)	2	Drain pipes for wash basins	2
Infrastructure required specific to differently abled section			
Ramp with hand rails for wheelchair	Yes	Barrier free access inside the facility	0
Disabled friendly cubicle size	0	Grab bar	0
Disabled friendly toilet seat	0	Wash basin at disabled friendly height	0
Infrastructure required specific to child friendly section			
Child friendly toilet seat	0	Urinal pot at child friendly height	0
Wash basin at child friendly height	0		
Other required amenities (as per ODF+ guidelines)

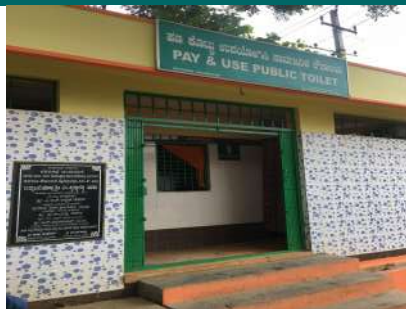
Unique ID - 7J5WC322+5P

<b>Address</b>	Kuvempu Rd KR Extension Chintamani	<b>Location</b>	Other:, R K Nursing Home
<b>Facility is constructed by</b>	Private agency/Trust/NGO	<b>O&amp;M agency</b>	Sri Sai foundation
<b>Most type of users</b>	Nearby shop owners/office employees/visitors	<b>Estimated number of users per day</b>	100
<b>Open 24x7</b>	No	<b>Opening time</b>	04:30
<b>Plan type of Facility</b>	Besides	<b>Closing time</b>	20:00

Cleanliness category of the Facility	Mandatory Service Indicators Score	Essential Service Indicators Score	Desirable service Indicators Score	Aspirational service Indicators Score
Usable but dirty	68%	28%	40%	23%

Water availability	Adequacy of facility	Overall Condition of the Building	Overall cleanliness of facility	Overall cleanliness of basins	Overall Lighting Facility
During operational hours	Under-used	Fair	Fair	Fair	Natural ventilation

Overall cleanliness of the facility	Fair	Supply of consumables cleaning equipment and inventory (Phenyl, Acid, Broom, Bucket, Mug)	Yes
Method of cleaning of toilet facility	Manually	Use of protective gears	No
No. of times facility cleaned in a day	2	Availability of day light	Natural ventilation
Supervisor/ caretaker on duty	Yes	Obstructions while accessing facility	Poor condition of path, Parking, Encroachment by vendors/hawkers, Gathering of males
Responsible for cleaning facility	Hired by O & m agency	Plants / shrubs in the vicinity of toilet block are well maintained	No
Stain / graffiti free walls and floors	Yes

Infrastructure required			
Toilet seat replacement (male and female)	0	Mugs/ bucket	0
Taps	0	Ventilators/ Exhaust fans	6
Flush for toilet facility	6	Hooks for hanging clothes	6
Door with proper latch	0	Separate lights in cubicles	3
Contact information display	1	Directional signage	1
Urinal Elements			
Total urinal pot (install/replace)	0	Discharge drain pipes in Urinal	0
Washbasin Elements			
Total wash basin (install/replace)	0	Drain pipes for wash basins	0
Infrastructure required specific to differently abled section			
Ramp with hand rails for wheelchair	Yes	Barrier free access inside the facility	0
Disabled friendly cubicle size	0	Grab bar	0
Disabled friendly toilet seat	0	Wash basin at disabled friendly height	0
Infrastructure required specific to child friendly section			
Child friendly toilet seat	0	Urinal pot at child friendly height	0
Wash basin at child friendly height	0		
Other required amenities (as per ODF+ guidelines)

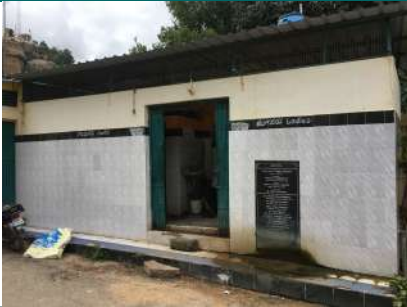
Unique ID - 7J5WC333+7R

General Information			
<b>Address</b>	Hari Hara Temple Building Dodda Pete Chintamani	<b>Location</b>	Public transit zones, Other:, Azad Chowk
<b>Facility is constructed by</b>	Private agency/Trust/NGO	<b>O&amp;M agency</b>	Sri Sai Foundation
<b>Most type of users</b>	Nearby shop owners/office employees/visitors	<b>Estimated number of users per day</b>	50
<b>Open 24x7</b>	No	<b>Opening time</b>	05:00
<b>Plan type of Facility</b>	Besides	<b>Closing time</b>	20:30

Cleanliness category of the Facility	Mandatory Service Indicators Score	Essential Service Indicators Score	Desirable service Indicators Score	Aspirational service Indicators Score
Unusable	27%	10%	40%	2%

Water availability	Adequacy of facility	Overall Condition of the Building	Overall cleanliness of facility	Overall cleanliness of basins	Overall Lighting Facility
Few hours a day	Under-used	Bad	Bad	Bad	Natural ventilation

Overall cleanliness of the facility	Bad	Supply of consumables cleaning equipment and inventory (Phenyl, Acid, Broom, Bucket, Mug)	Yes
Method of cleaning of toilet facility	Manually	Use of protective gears	No
No. of times facility cleaned in a day	2	Availability of day light	Natural ventilation
Supervisor/ caretaker on duty	Yes	Obstructions while accessing facility	Poor condition of path, Parking, Encroachment by vendors/hawkers, Gathering of males
Responsible for cleaning facility	Hired by O & m agency	Plants / shrubs in the vicinity of toilet block are well maintained	No
Stain / graffiti free walls and floors	No

Infrastructure required			
Toilet seat replacement (male and female)	0	Mugs/ bucket	0
Taps	1	Ventilators/ Exhaust fans	5
Flush for toilet facility	5	Hooks for hanging clothes	5
Door with proper latch	3	Separate lights in cubicles	4
Contact information display	1	Directional signage	1
Urinal Elements			
Total urinal pot (install/replace)	0	Discharge drain pipes in Urinal	0
Washbasin Elements			
Total wash basin (install/replace)	0	Drain pipes for wash basins	0
Infrastructure required specific to differently abled section			
Ramp with hand rails for wheelchair	Yes	Barrier free access inside the facility	0
Disabled friendly cubicle size	0	Grab bar	0
Disabled friendly toilet seat	0	Wash basin at disabled friendly height	0
Infrastructure required specific to child friendly section			
Child friendly toilet seat	0	Urinal pot at child friendly height	0
Wash basin at child friendly height	0		
Other required amenities (as per ODF+ guidelines)

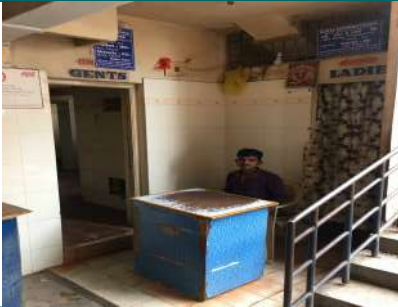
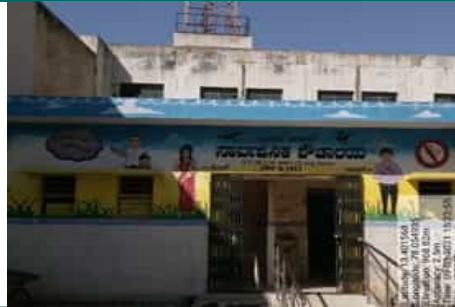
Unique ID -  
7J5WC324+W3

<b>Address</b>	PCR Complex Hotel St Chintamani	<b>Location</b>	Other:, IDSMT complex
<b>Facility is constructed by</b>	Private agency/Trust/NGO	<b>O&amp;M agency</b>	Surya international social service organization
<b>Most type of users</b>	Nearby shop owners/office employees/visitors	<b>Estimated number of users per day</b>	150
<b>Open 24x7</b>	No	<b>Opening time</b>	05:00
<b>Plan type of Facility</b>	Disjointed	<b>Closing time</b>	21:00

Cleanliness category of the Facility	Mandatory Service Indicators Score	Essential Service Indicators Score	Desirable service Indicators Score	Aspirational service Indicators Score
Usable but dirty	67%	22%	40%	2%

Water availability and waste water disposal			
Sources of water supply	Tanker	Method of waste water disposal	Sewer Connection
Responsible for emptying septic tank	N.A.		
Overall cleanliness and operations			
Overall cleanliness of the facility	Bad	Supply of consumables cleaning equipment and inventory (Phenyl, Acid, Broom, Bucket, Mug)	Yes
Method of cleaning of toilet facility	Manually	Use of protective gears	No
No. of times facility cleaned in a day	2	Availability of day light	Natural ventilation
Supervisor/ caretaker on duty	Yes	Obstructions while accessing facility	Poor condition of path, Parking, Encroachment by vendors/hawkers, Gathering of males
Responsible for cleaning facility	Hired by O & m agency	Plants / shrubs in the vicinity of toilet block are well maintained	No
Stain / graffiti free walls and floors	No

Infrastructure required			
Toilet seat replacement (male and female)	0	Mugs/ bucket	0
Taps	0	Ventilators/ Exhaust fans	5
Flush for toilet facility	5	Hooks for hanging clothes	5
Door with proper latch	0	Separate lights in cubicles	3
Contact information display	1	Directional signage	1
Urinal Elements			
Total urinal pot (install/replace)	0	Discharge drain pipes in Urinal	0
Washbasin Elements			
Total wash basin (install/replace)	0	Drain pipes for wash basins	0
Infrastructure required specific to differently abled section			
Ramp with hand rails for wheelchair	Yes	Barrier free access inside the facility	0
Disabled friendly cubicle size	0	Grab bar	0
Disabled friendly toilet seat	0	Wash basin at disabled friendly height	0
Infrastructure required specific to child friendly section			
Child friendly toilet seat	0	Urinal pot at child friendly height	0
Wash basin at child friendly height	0		
Other required amenities (as per ODF+ guidelines)

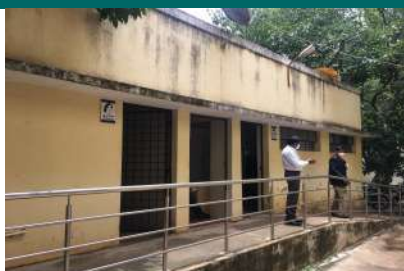
Unique ID - 7J5W93X2+CP

General Information			
Address	College Rd Chintamani Chikballapur	Location	Other:, COURT
Facility is constructed by	Urban Local Body (Municipality or Municipal Corporation)	O&M agency	N.A.
Most type of users	Nearby shop owners/office employees/visitors	Estimated number of users per day	60
Open 24x7	No	Opening time	10:00
Plan type of Facility	Besides	Closing time	17:00

Cleanliness category of the Facility	Mandatory Service Indicators Score	Essential Service Indicators Score	Desirable service Indicators Score	Aspirational service Indicators Score
Usable but dirty	80%	28%	40%	23%

Water availability and waste water disposal			
Sources of water supply	Municipal Connection	Method of waste water disposal	Sewer Connection
Responsible for emptying septic tank	N.A.		
Overall cleanliness and operations			
Overall cleanliness of the facility	Fair	Supply of consumables cleaning equipment and inventory (Phenyl, Acid, Broom, Bucket, Mug)	Yes
Method of cleaning of toilet facility	Manually	Use of protective gears	No
No. of times facility cleaned in a day	2	Availability of day light	Natural ventilation
Supervisor/ caretaker on duty	Yes	Obstructions while accessing facility	Parking, Gathering of males
Responsible for cleaning facility	ULB appointed staff	Plants / shrubs in the vicinity of toilet block are well maintained	No
Stain / graffiti free walls and floors	Yes

Infrastructure required			
Toilet seat replacement (male and female)	0	Mugs/ bucket	1
Taps	0	Ventilators/ Exhaust fans	0
Flush for toilet facility	6	Hooks for hanging clothes	6
Door with proper latch	0	Separate lights in cubicles	1
Contact information display	1	Directional signage	1
Urinal Elements			
Total urinal pot (install/replace)	0	Discharge drain pipes in Urinal	0
Washbasin Elements			
Total wash basin (install/replace)	1	Drain pipes for wash basins	1
Infrastructure required specific to differently abled section			
Ramp with hand rails for wheelchair	No	Barrier free access inside the facility	0
Disabled friendly cubicle size	0	Grab bar	0
Disabled friendly toilet seat	0	Wash basin at disabled friendly height	1
Infrastructure required specific to child friendly section			
Child friendly toilet seat	0	Urinal pot at child friendly height	0
Wash basin at child friendly height	0		
Other required amenities (as per ODF+ guidelines)

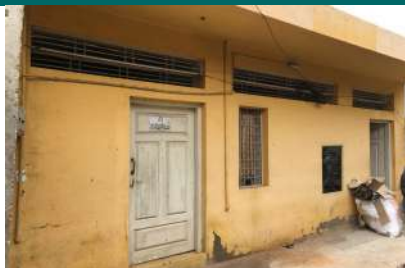
Unique ID - 7J5W93X2+RQ

General Information			
Address	Government Polytechnic College Chintamani Chintamani	Location	Other:, Stadium
Facility is constructed by	Private agency/Trust/NGO	O&M agency	Sri Sai foundation
Most type of users	Nearby shop owners/office employees/visitors	Estimated number of users per day	200
Open 24x7	No	Opening time	08:00
Plan type of Facility	Besides	Closing time	17:00

Cleanliness category of the Facility	Mandatory Service Indicators Score	Essential Service Indicators Score	Desirable service Indicators Score	Aspirational service Indicators Score
Unusable	39%	9%	25%	23%

Water availability and waste water disposal			
Sources of water supply	Municipal Connection	Method of waste water disposal	Sewer Connection
Responsible for emptying septic tank	N.A.		
Overall cleanliness and operations			
Overall cleanliness of the facility	Bad	Supply of consumables cleaning equipment and inventory (Phenyl, Acid, Broom, Bucket, Mug)	Yes
Method of cleaning of toilet facility	Manually	Use of protective gears	No
No. of times facility cleaned in a day	1	Availability of day light	No ventilation
Supervisor/ caretaker on duty	No	Obstructions while accessing facility	Poor condition of path, Parking, Encroachment by vendors/hawkers, Gathering of males
Responsible for cleaning facility	Hired by O & m agency	Plants / shrubs in the vicinity of toilet block are well maintained	No
Stain / graffiti free walls and floors	Yes

Infrastructure required			
Toilet seat replacement (male and female)	0	Mugs/ bucket	1
Taps	2	Ventilators/ Exhaust fans	5
Flush for toilet facility	4	Hooks for hanging clothes	5
Door with proper latch	1	Separate lights in cubicles	5
Contact information display	1	Directional signage	1
Urinal Elements			
Total urinal pot (install/replace)	0	Discharge drain pipes in Urinal	0
Washbasin Elements			
Total wash basin (install/replace)	2	Drain pipes for wash basins	3
Infrastructure required specific to differently abled section			
Ramp with hand rails for wheelchair	Yes	Barrier free access inside the facility	2
Disabled friendly cubicle size	0	Grab bar	2
Disabled friendly toilet seat	0	Wash basin at disabled friendly height	2
Infrastructure required specific to child friendly section			
Child friendly toilet seat	0	Urinal pot at child friendly height	0
Wash basin at child friendly height	0		
Other required amenities (as per ODF+ guidelines)

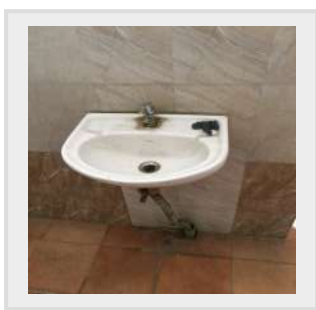
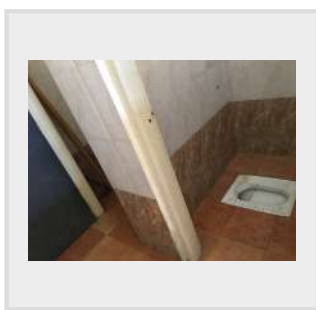
Condition of the facility					
Water availability	Adequacy of facility	Overall Condition of the Building	Overall cleanliness of facility	Overall cleanliness of basins	Overall Lighting Facility
Few hours a day	Inadequate	Bad	Bad	Bad	No ventilation
Estimated Cost of Refurbishment ₹ 57830					
Plumbing fixtures		₹ 14950	Electrical Fixtures		₹ 1820
			Others Fixtures		₹ 41060

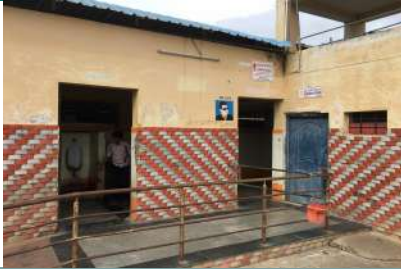
Unique ID - 7J5WC324+3M

Cleanliness category of the Facility	Mandatory Service Indicators Score	Essential Service Indicators Score	Desirable service Indicators Score	Aspirational service Indicators Score
Usable but dirty	67%	24%	40%	23%

Water availability and waste water disposal			
Sources of water supply	Municipal Connection	Method of waste water disposal	Sewer Connection
Responsible for emptying septic tank	N.A.		
Overall cleanliness and operations			
Overall cleanliness of the facility	Bad	Supply of consumables cleaning equipment and inventory (Phenyl, Acid, Broom, Bucket, Mug)	Yes
Method of cleaning of toilet facility	Manually	Use of protective gears	No
No. of times facility cleaned in a day	2	Availability of day light	Natural ventilation
Supervisor/ caretaker on duty	Yes	Obstructions while accessing facility	Parking, Encroachment by vendors/hawkers, Gathering of males
Responsible for cleaning facility	Hired by O & m agency	Plants / shrubs in the vicinity of toilet block are well maintained	No
Stain / graffiti free walls and floors	Yes

Infrastructure required			
Toilet seat replacement (male and female)	0	Mugs/ bucket	0
Taps	0	Ventilators/ Exhaust fans	0
Flush for toilet facility	25	Hooks for hanging clothes	22
Door with proper latch	0	Separate lights in cubicles	12
Contact information display	1	Directional signage	1
Urinal Elements			
Total urinal pot (install/replace)	0	Discharge drain pipes in Urinal	0
Washbasin Elements			
Total wash basin (install/replace)	2	Drain pipes for wash basins	2
Infrastructure required specific to differently abled section			
Ramp with hand rails for wheelchair	No	Barrier free access inside the facility	0
Disabled friendly cubicle size	0	Grab bar	0
Disabled friendly toilet seat	0	Wash basin at disabled friendly height	2
Infrastructure required specific to child friendly section			
Child friendly toilet seat	0	Urinal pot at child friendly height	0
Wash basin at child friendly height	0		
Other required amenities (as per ODF+ guidelines)
