Public & Community Toilet Chikkaballapur City

Assessment Report

Public Toilet Assessment, Ambedkar Bhavana, Chikkaballapur

August 2021

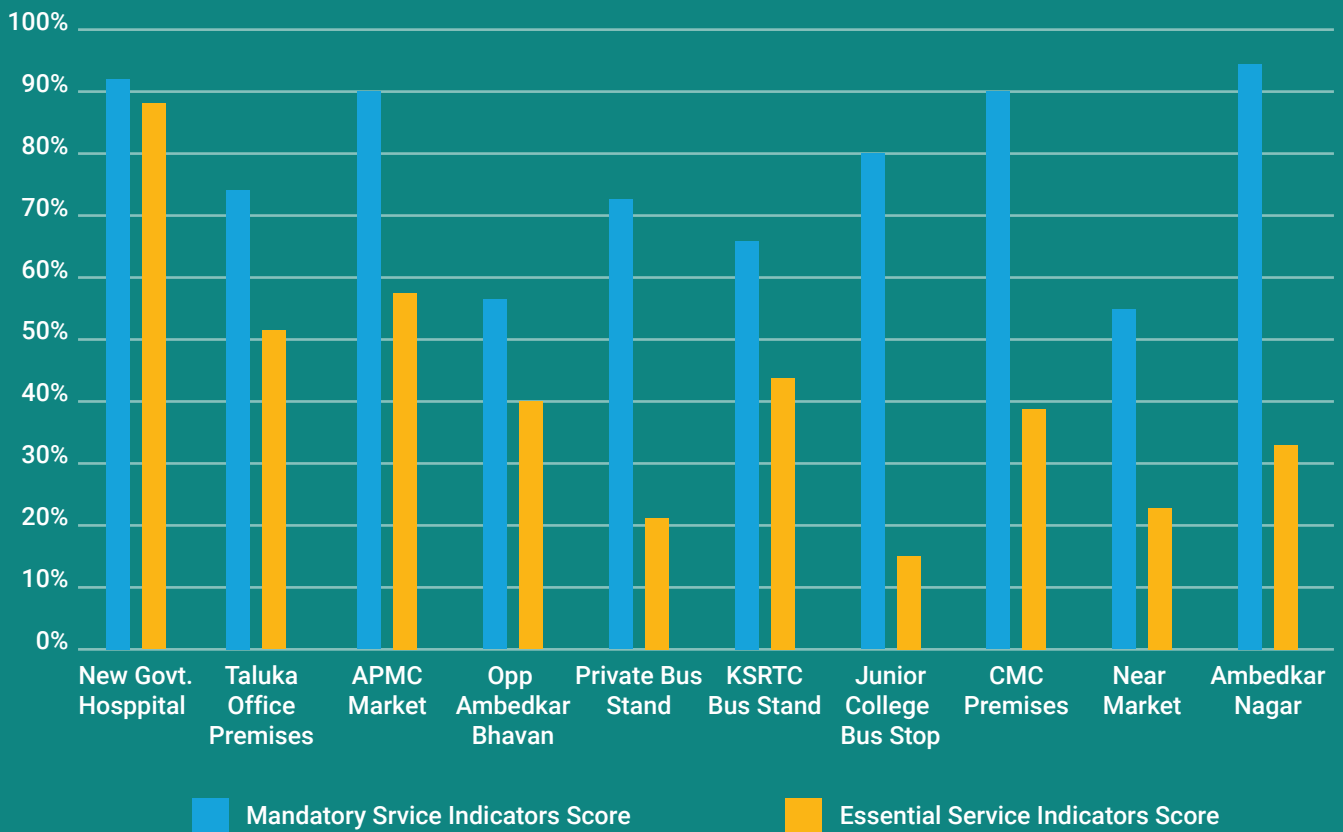
Figure 5

Public toilet score (percentage) as per Mandatory and Essential Service Indicator

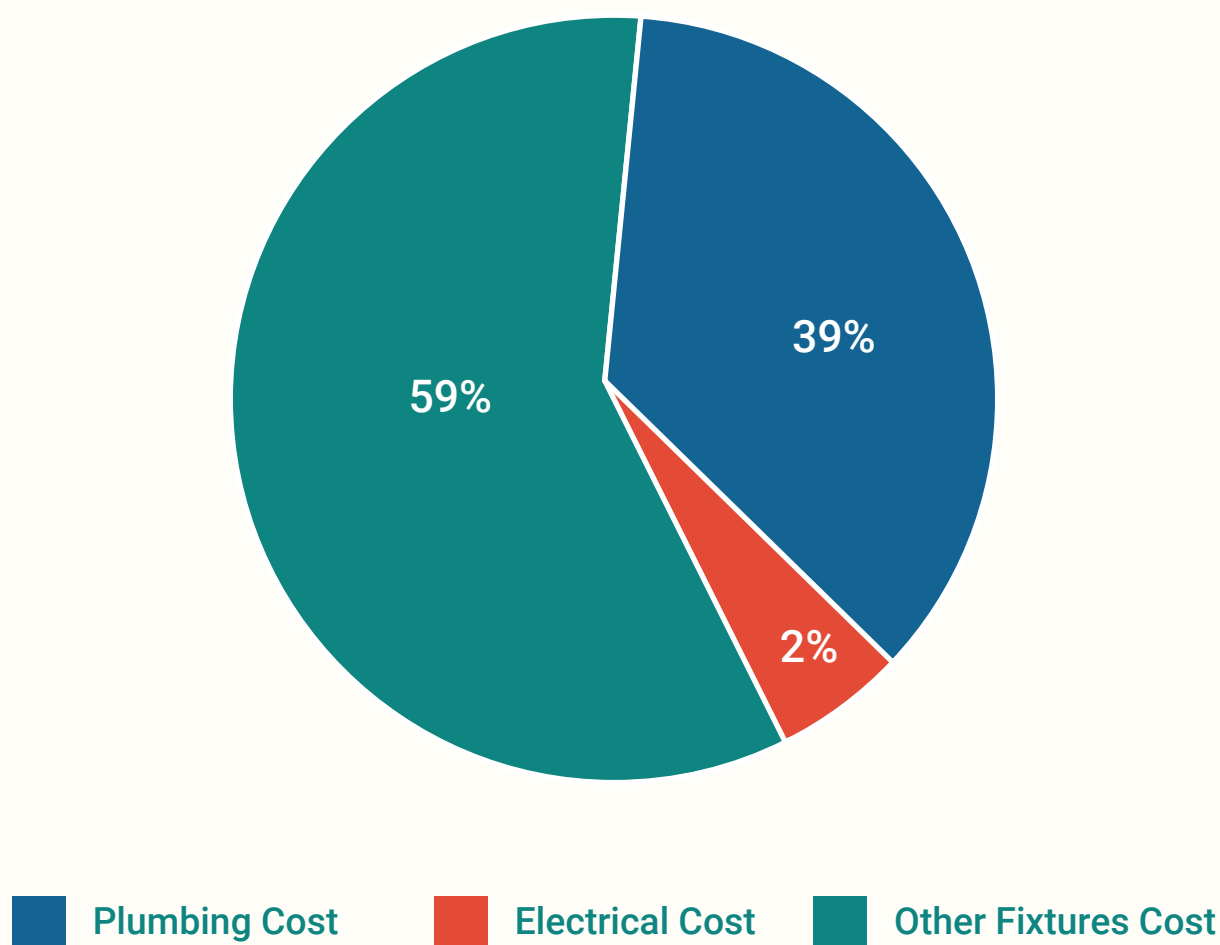
Figure 8

Estimated average refurbishment budget: Based on the sanitation mapping tool, the approximate budget required for refurbishment of PTs: Rs. 5,29,930. Around 40% of overall refurbishment cost will be required for plumbing fixtures, 3% for electrical fixtures and 57% for other fixtures cost (refer Figure 5). Plumbing fixtures includes toilet seats, urinal pots, washbasins, taps, flush and drain pipes; electrical fixtures constitutes for lighting in the cubicles and outdoor lightings and other fixtures include sanitary and operation and maintenance equipment namely mirrors, mugs, sanitary pad vending machine, signage, hand dryer, door with latch, dustbins, hooks, incinerator of sanitary pads, air freshener and ventilators/exhaust fans. The details of these costs against various components for each toilet is given in Annexure 1.

Approximate refurbishment cost for plumbing, electrical and other fixtures for all toilets

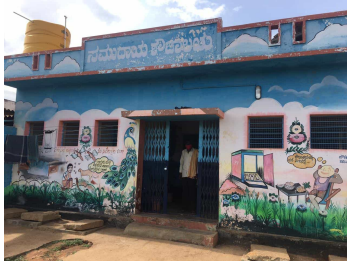
Unique ID - 7J5V2H7F+JG

Community Toilet Free to use

| Address | 239/A1 11th Cross Rd Kodandarampura | Location | Slum |

| Cleanliness category of the Facility | Mandatory Service Indicators Score | Essential Service Indicators Score | Desirable service Indicators Score | Aspirational service Indicators Score |
|---|---|---|---|---|
| Usable but dirty | 94% | 33% | 40% | 34% |

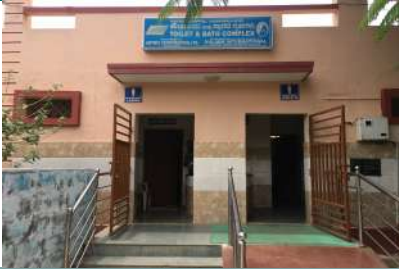
Unique ID - 7J5VCPGP+65

Public Toilet Pay & Use (for all)

| Address | Unnamed Road Chikkaballapur Chikballapur | Location | Other:, New Government Hospital |

| Cleanliness category of the Facility | Mandatory Service Indicators Score | Essential Service Indicators Score | Desirable service Indicators Score | Aspirational service Indicators Score |
|---|---|---|---|---|
| Clean | 91% | 89% | 40% | 36% |

| Infrastructure required | | | |
|---|---|---|---|
| Total wash basin (install/replace) | 2 | Drain pipes for wash basins | 2 |

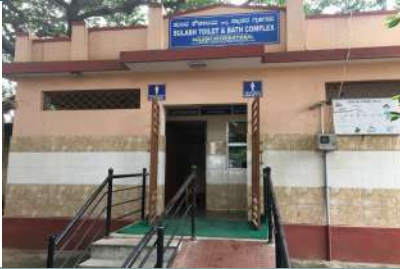
Unique ID - 7J5VCPPH+JM

Public Toilet Pay & Use (for all)

| General Information | | | |
|---|--|---|---|
| Address | CPPH+MPX Chikkaballapur Chikballapur | Location | Other:, Taluka Office Premises |

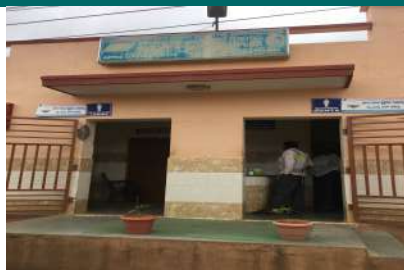
Unique ID - 7J5VCPQC+93

Public Toilet Pay & Use (for all)

| Address | NH 69 Chikkaballapur Chikballapur | Location | Market, Other:, APMC Market |

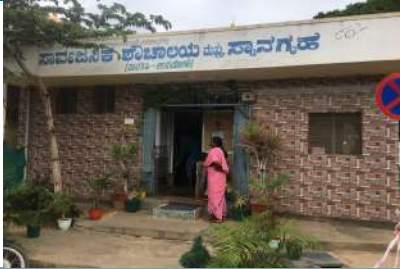
Unique ID - 7J5VCPH+RQ

Public Toilet Pay & Use (for all)

| Address | Unnamed Road Chikkaballapur Chikballapur | Location | Other:, Opp Ambedkar Bhavana |

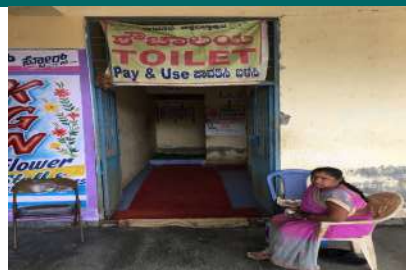
Unique ID - 7J5VCPJ+C8

Public Toilet Pay & Use (for all)

| General Information | | | |
|---|--|---|---|
| Address | Bus Depot Chikkaballapur Chikballapur | Location | Public transit zones, Other:, Private Bus stand |

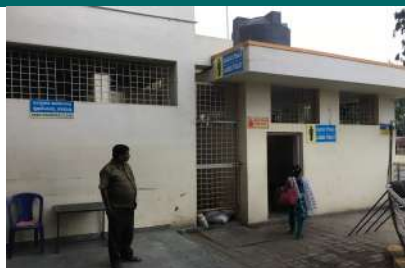
Unique ID - 7J5VCPQJ+3X

Public Toilet Pay & Use (for all)

| Address | BB Rd KEB Colony Chikkaballapur | Location | Public transit zones, Other:, KSRTC Bus Stand |

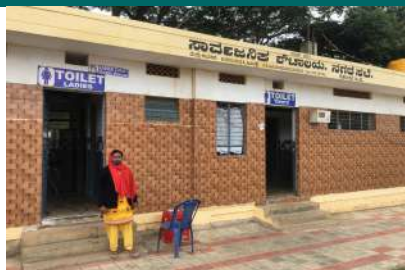
Unique ID - 7J5VCPHJ+F6

Public Toilet Pay & Use (for all)

| Address | SH 74 Chikkaballapur Chikballapur | Location | Road Side, Other:, Junior college buss stop |

| Cleanliness category of the Facility | Mandatory Service Indicators Score | Essential Service Indicators Score | Desirable service Indicators Score | Aspirational service Indicators Score |
|---|---|---|---|---|
| Usable but dirty | 80% | 15% | 40% | 23% |

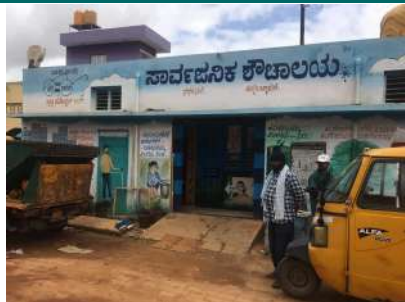
Unique ID - 7J5V2H7F+JG

Public Toilet Free to use

| General Information | | | |
|---|--|---|--|
| Address | 239/A1 11th Cross Rd Kodandarampura | Location | Other:, City Municipal Corporation, Chikkaballapur |

| Cleanliness category of the Facility | Mandatory Service Indicators Score | Essential Service Indicators Score | Desirable service Indicators Score | Aspirational service Indicators Score |
|---|---|---|---|---|
| Usable but dirty | 73% | 20% | 40% | 45% |

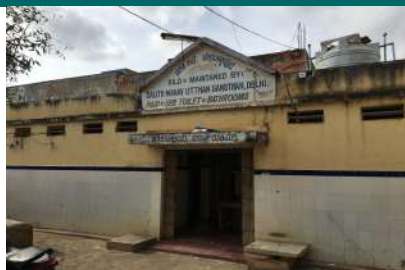
Unique ID - 7J5VCPHJ+XF

Public Toilet Pay & Use (for all)

| General Information | | | |
|---|--|---|---|
| Address | Unnamed Road Chikkaballapur Chikballapur | Location | Market |

| Cleanliness category of the Facility | Mandatory Service Indicators Score | Essential Service Indicators Score | Desirable service Indicators Score | Aspirational service Indicators Score |
|---|---|---|---|---|
| Unusable | 55% | 22% | 40% | 23% |
